Optimum operating temperature in a water-cooled engine is provided by a system that circulates coolant through the engine block water jacket and the radiator. The water pump is the mechanism that maintains the constant flow of coolant. In most cases, the water pump is driven by a belt pulley system, where the pulley receives power from the engine's drive belt, timing belt, or fan belt.

2 Structure and Components

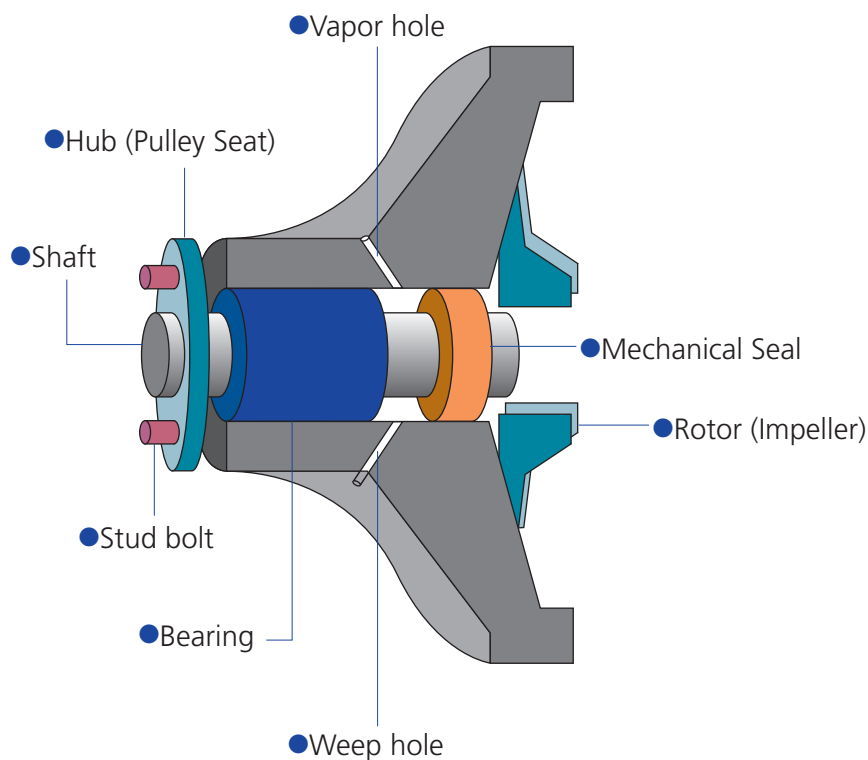
The structure of the water pump is comprised of the following components: pulley hub, body, shaft, bearing, mechanical seal and rotor (impeller). The shaft is mounted onto a bearing which is pressed into the water pump body. On one end of the shaft, a pulley hub is attached, while the other end is a rotor (impeller). The pulley hub transfers energy from the fan or timing belt into a rotation, spinning the shaft, therefore spinning the rotor. The rotor then circulates the coolant. A mechanical seal is installed to prevent leakage of coolant into the bearing and also supports the shaft for smooth rotation.

The body of the water pump is equipped with a vapor hole and a weep hole. The vapor hole relieves excess gas pressure seeping through the mechanical seal. The weep hole bleeds off excess coolant seeping through the mechanical seal. Both holes function as a safety to protect the shaft and the bearing from contamination.

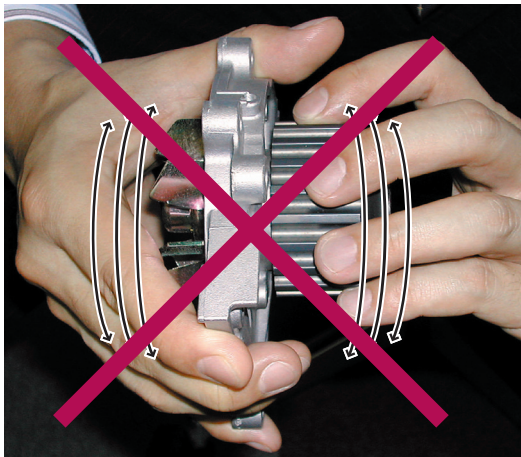
1. Do not dry turn the pulley!

WARNING!
Dry turning will damage the mechanical seal. Pre-lubricate before turning.

Do not manually turn the pulley before installation of the water pump. In the mechanical seal, the soft carbon block may create residue on the ceramic block, generating abnormal (squealing) noises during operation.

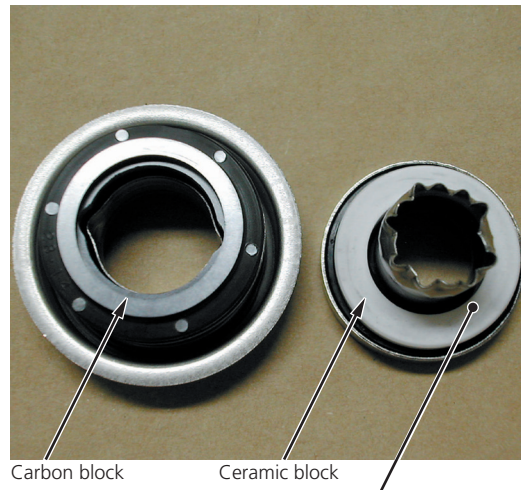
2. Seal Damage Example: Mechanical Seal Inner View

Dry turning will deposit carbon onto the ceramic block, causing squealing during operation.

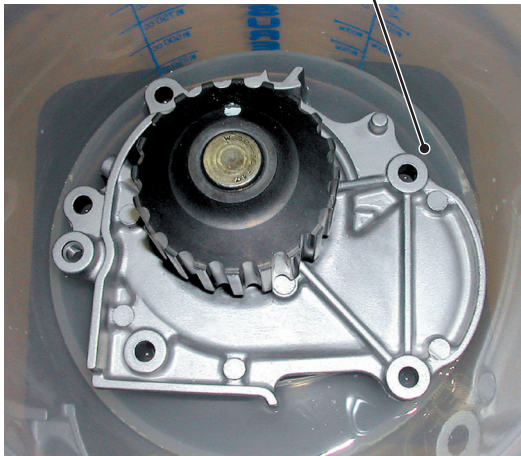
3. Pre-lubrication

Submerge the lower part of the pump body and the base of the rotor.

It is recommended that the lower part of the water pump is submerged in water for approximately 3 minutes prior to installation. This is to form a layer of water between the carbon and ceramic blocks in the mechanical seal, and prevent abnormal (squealing) noises from being generated. (Some noise may be heard at initial start-up, but will disappear after engine warm-up.)

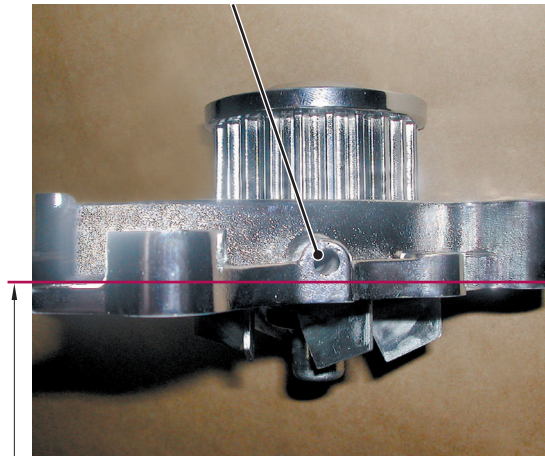
4. Water level

Caution: Do not submerge the weep hole or vapor hole in water.

Submerge the water pump body below the red line

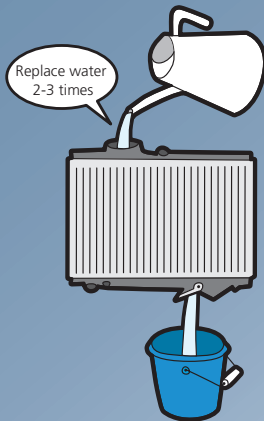
1

Flush the radiator 2-3 times with water while letting the engine idle. This will remove scale, rust deposits and sludge from the coolant system.

Prevents foreign materials from contaminating the new water pump mechanical seal.

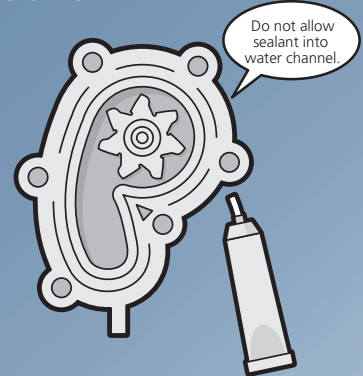
3

If a sealant is needed, apply an even amount around the pump. Wipe off excess and make sure the sealant(RTV) does not intrude into the water channel.

Excess sealant material may damage the mechanical seal, which may cause pump failure.

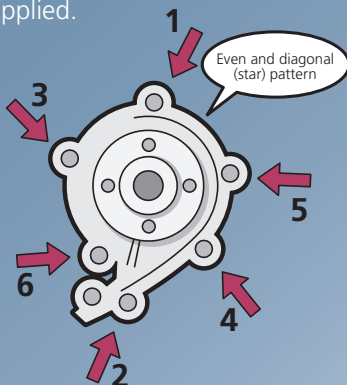
4

Install the new water pump in a diagonal (star) pattern and apply torque specified by the vehicle manufacturer. Allow sealant(RTV) to cure if applied.

- Prevents leakage from the mounting surface.
- Prevents body damage from installation.
- Prevents body fractures caused by belt tension.

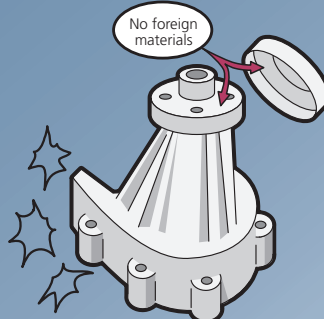
5

Confirm that the fan coupling is free of rust and contaminants. After installation, verify run-out tolerances specified by the manufacturer using a dial indicator.

Prevents fractures and damage caused by backlash or wobble of the pulley or fan coupling.

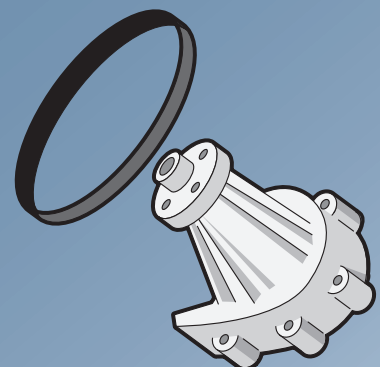
6

Install the fan belt or timing belt and apply tension specified by the manufacturer.

- Prevents fractures and damages caused by belt tension.
- Prevents noise.

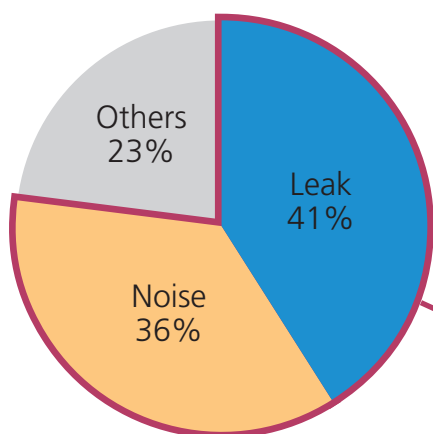
Failure Rate by Cause (Customer complaints)

More than 75% of failures are due to complaints related to coolant leaks and noise occurring from the water pump. To prevent most water pump problems from occurring, follow the 4 key steps described in the installation procedures from steps:

- 1** Flush the radiator and coolant system regularly
- 6** Tighten belt to vehicle manufacture specified tension
- 7** Re-fill with new coolant (LLC)
- 8** Bleed air completely

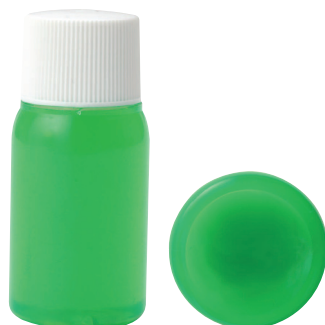
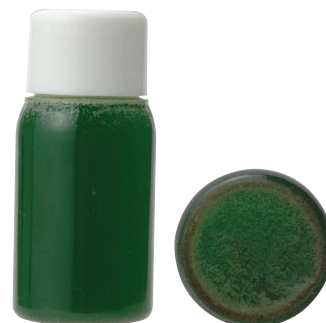
① Coolant degradation

New

38,000 km (23,000 miles) 4 years old

- Older coolants have higher risks of leakage.
- Always flush the radiator and replace with new coolant.
 - Replace coolant regularly.

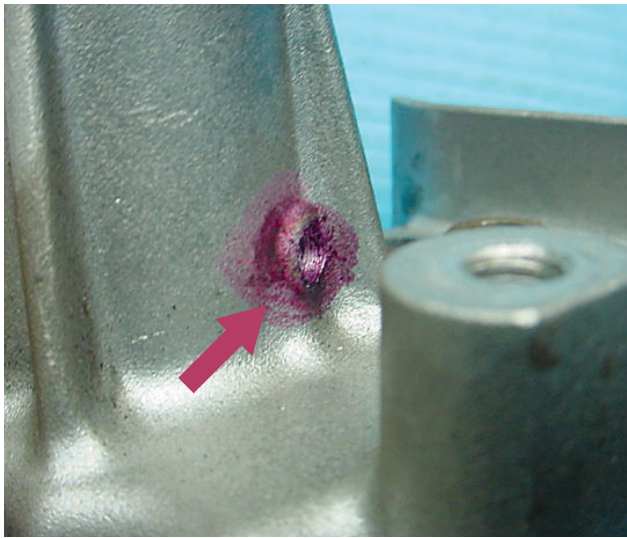
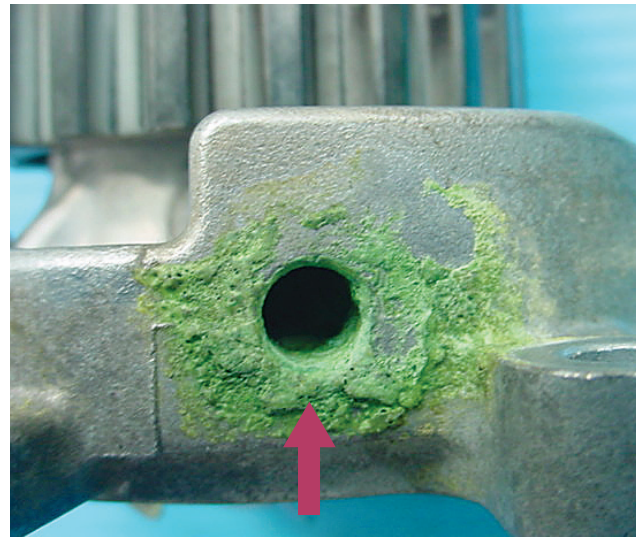
② Fair and Poor, leak from the weep hole

Normal Dried coolant residue.

Damaged Large coolant bleed mark, dampness or dripping.

- The weep hole protects bearings from corrosion damage by preventing seepage of coolant into the pump body.
- In normal operation, traces of dried coolant may be visible around the hole. Coolant leak may be occurring if there is fluid around the weep hole or if the reservoir tank reaches low coolant levels within about a month.

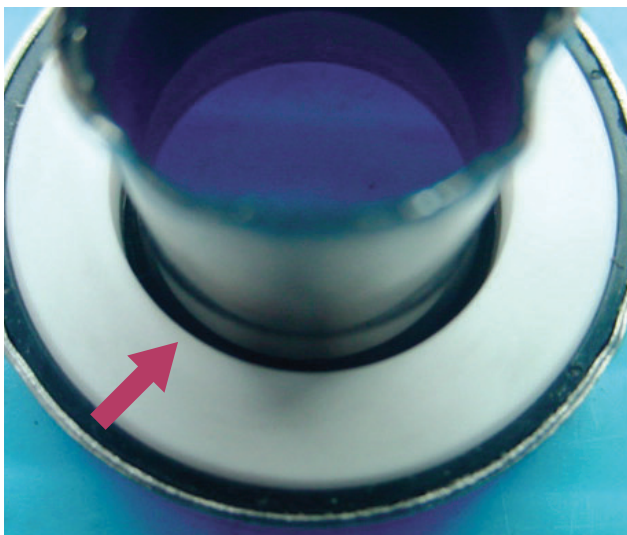
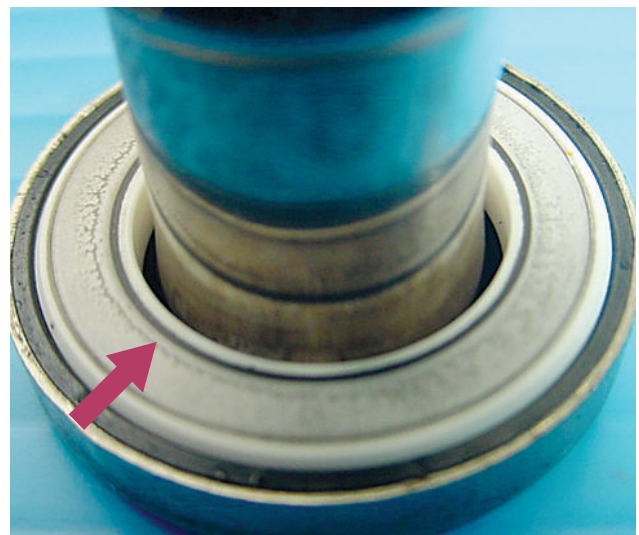
③ Fair and Poor, mechanical seal ceramic

Normal Clean ceramic.

Damaged Accumulated sludge (Contaminated coolant).

- Contamination and sludge has damaged the mechanical seal, reducing sealing performance.

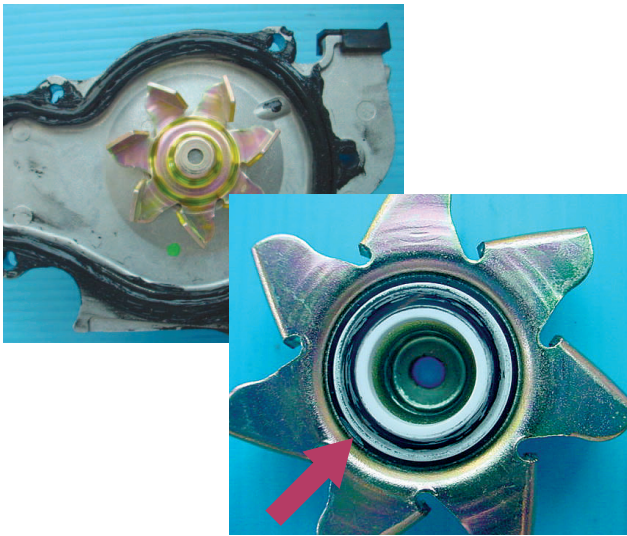
① Poor application of sealant

Sealant has interfered with the mechanical seal causing leaks.

- Use manufacturer's specified sealant if it is designated
- Do not use sealants when gaskets are supplied
- Do not use adhesives in place of sealants or gaskets
- Install the new water pump in a diagonal (star) pattern and apply torque specified by the vehicle manufacturer
- Clean mounting surface free of contaminants
- Do not re-use old gaskets and previously applied sealant

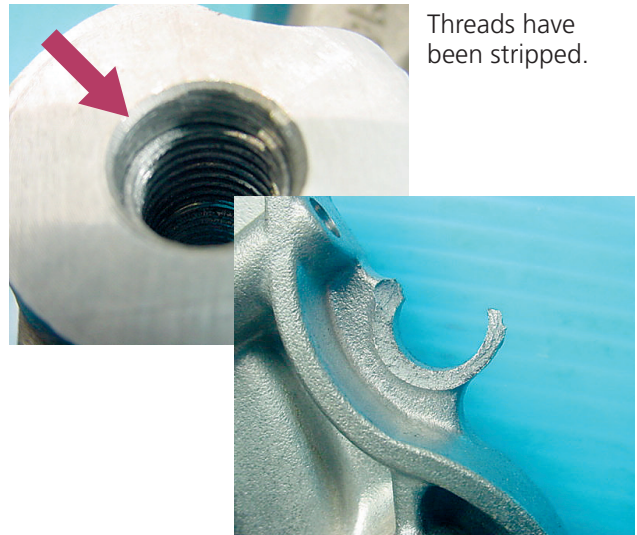
② Excess torque of the mounting bolt

Threads have been stripped.

Unevenly tightened or over torqued.

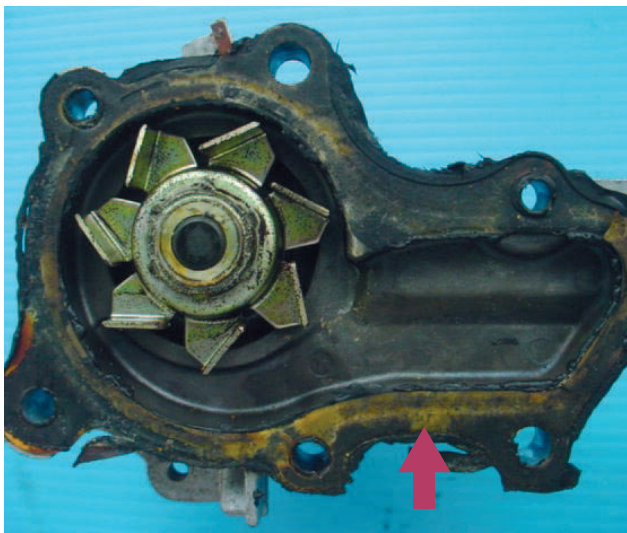
③ Poor cleaning of the mounting surface

Insufficient accuracy on the mounting surface.

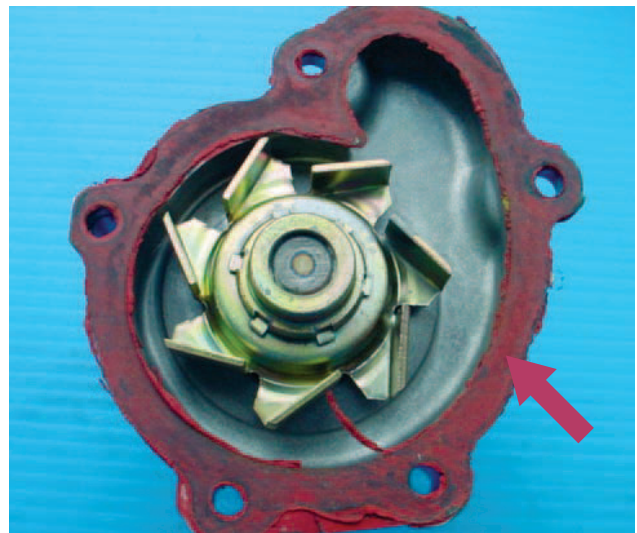
④ Sealant used on supplied gasket

Gasket performance has degraded.

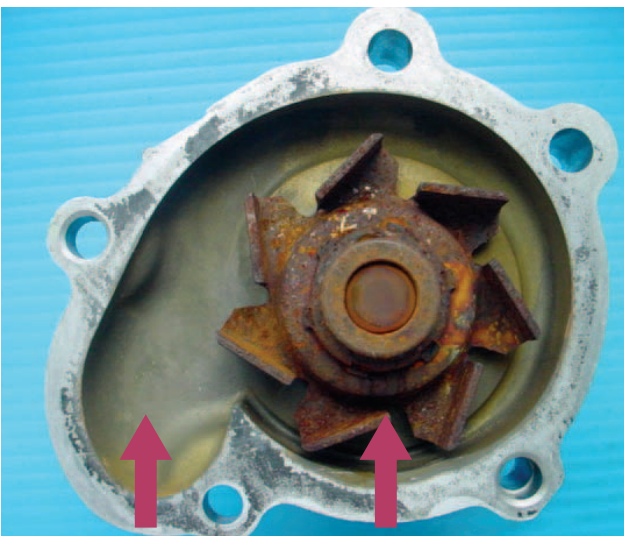
① Coolant degradation

Contamination of
water pump body

Impeller corrosion

- Discontinue use of old coolant
- Fully flush the radiator
- Replace coolant with manufacturer's specified mixture and fluid level
- Purge air from system

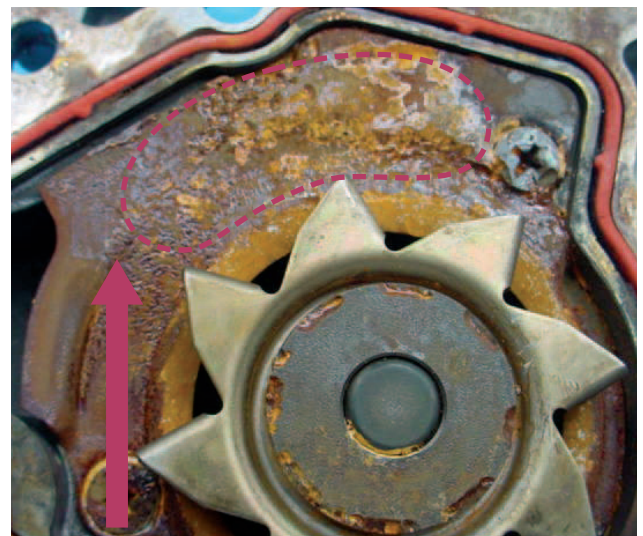
② Cavitation

Cavitation

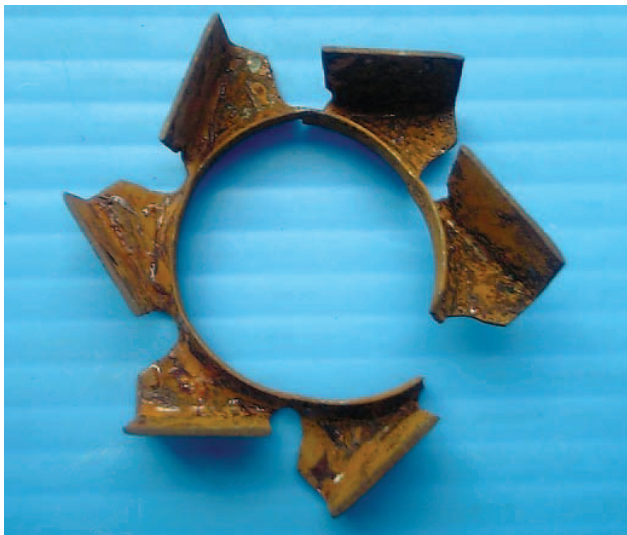
① Severely corroded impeller

When replacing the water pump, flush the coolant system 2 to 3 times to wash out sludge, scale and rust deposits. Replace coolant to the manufacturer's specified mixture and fluid level. Re-using or using degraded coolant will corrode the body, impeller, and mechanical seals.

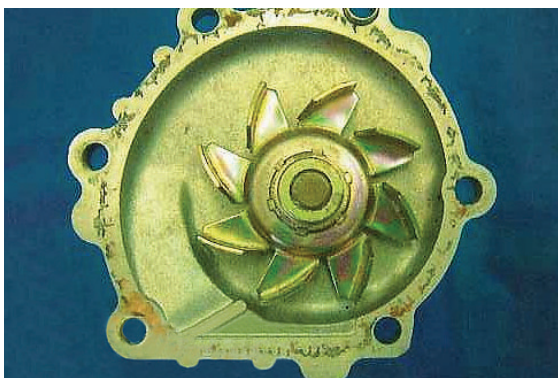
No corrosion can be seen on the impeller when the coolant is clean.

Mileage: 48,000 km (30,000 miles)
Period: Approximately 1.6 years
Total mileage: 149,000 km (92,500 miles)

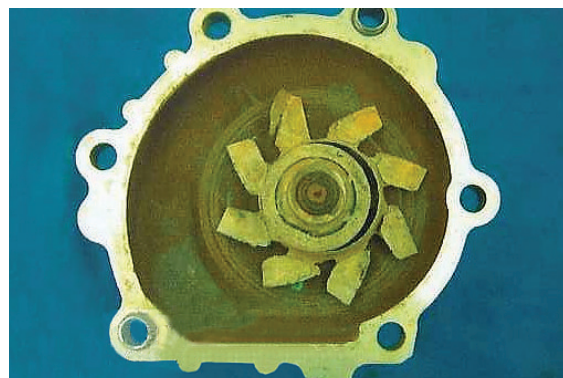
Corrosion can be seen on the impeller when the coolant is degraded (contaminated / deteriorated).

Mileage: 7,500 km (4,700 miles)
Period: Approximately 1 year
Total mileage: 105,000 km (65,000 miles)

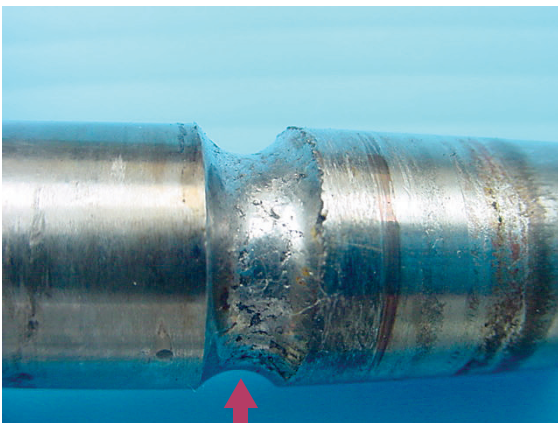
Flecking at the bearing

- Bearing fracture caused by excess belt tension
- Bearing was fractured due to excess vibrations caused by misalignment of parts such as the fan coupling pulley
- Uneven torque of bolts resulted in bearing failure
- Contamination of the pulley seat

Damage due to overload and seepage

- Tighten belt tension to vehicle manufacturer specifications
- If the fan coupling pulley is reused, confirm the run-out with a dial indicator
- Replace fan coupling pulley with new on older vehicles or high mileage engines
- Confirm that the bearing is lubed and no rumbling sound is heard, and replace if necessary

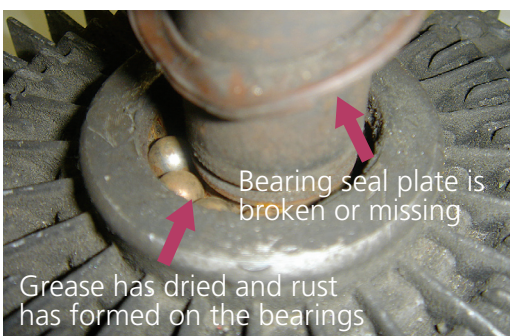
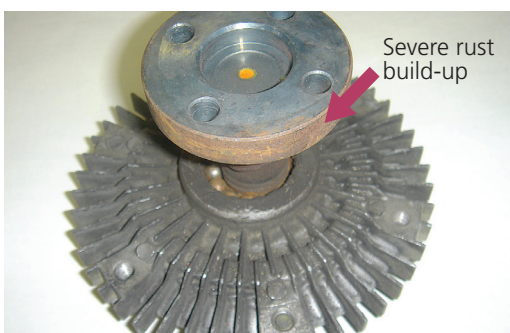
① Enlarged view of a fan coupling

- Reused damaged fan coupling
- Fan coupling was not installed correctly (off-centered)

If usage is continued

- Install new fan coupling when replacing water pump
- If fan coupling is reused, ensure that:
 - there is no binding or play in the bearing
 - bearing seal plate is securely fastened
 - the components are free of rust and debris
 - check for run-out with a dial indicator

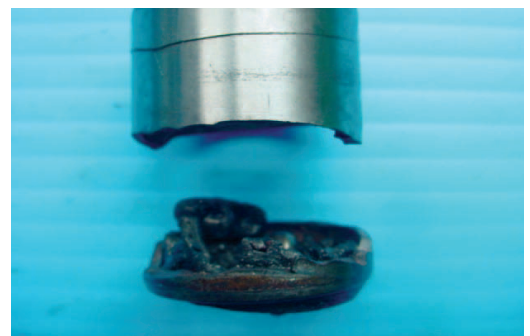
② Fractured bearing

- Fracture of the water pump body
- Fracture of the water pump bearing
