NVR vs. Conventional type - Component Comparison

Clutch Disc & Cover

2 AISIN Clutch Characteristics

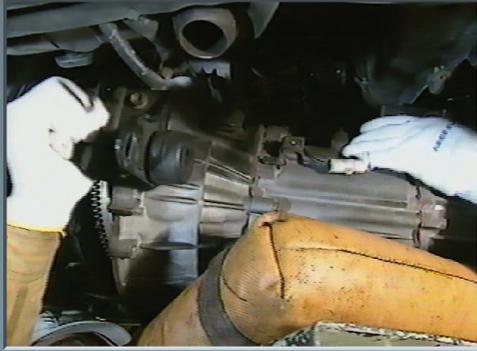
1 Use caution in the disassembly of the transmission and clutch components from the engine.

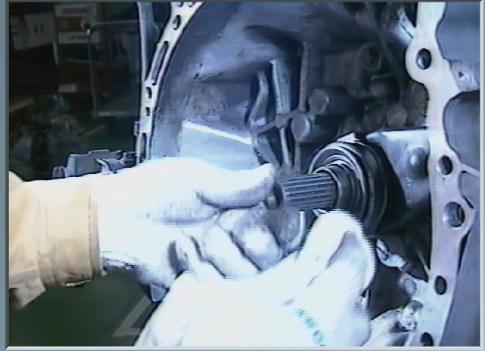
2 Clean the Input Shaft.

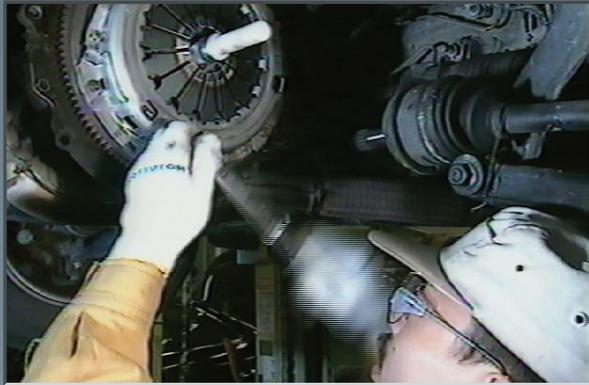
4 Use the clutch alignment tool to locate the clutch disc with the input bearing while tightening the clutch cover bolts. Tighten bolts with torque wrench in a diagonal (star) pattern.

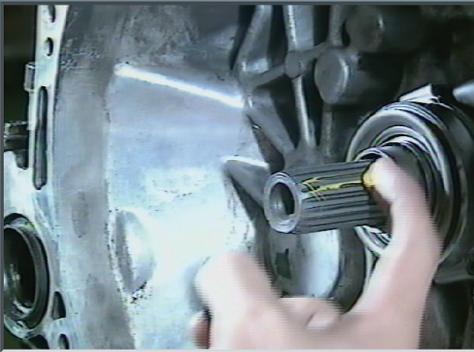
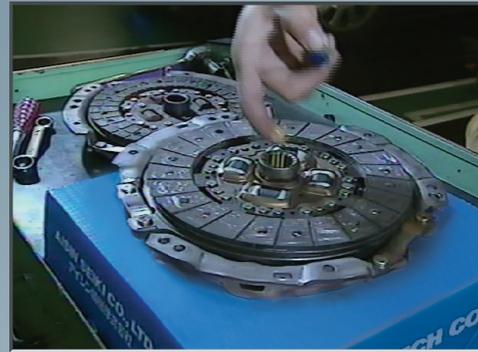
Apply appropriate amount of grease on the input shaft and disc spline.

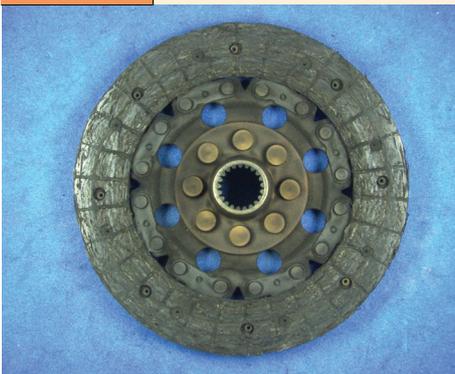
Condition: Facings are worn.

1. Facings have reached the end of its wear life.
2. Facings have been scorched due to excessive partial clutch engagement, excessive 2nd gear starts, or excessive downshifting, etc.
3. Improper driving method.

1. Improve driving method.
2. Replace disc and cover with new parts.

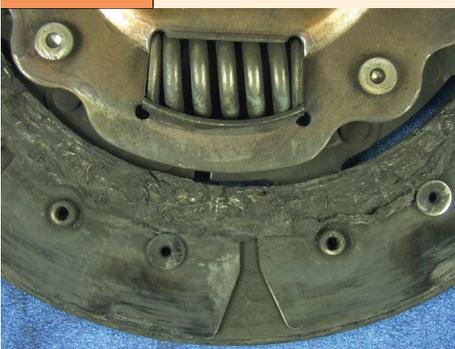
Condition: Facings have broken.

1. Facings have burst due to rapid change in torque (i.e.: mis-shifting or speed shifting).
2. Vehicle was driven with scorched facings.
3. Improper driving method.

1. Improve driving method.
2. Replace disc and cover with new parts.

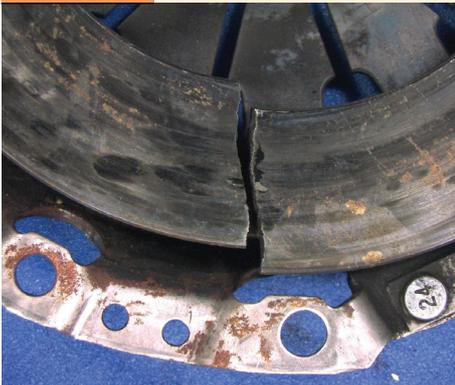
Condition: Pressure of the diaphragm spring is weak.

Disc Related Causes	Cover Related Causes	Other Causes
Cause:		<ol style="list-style-type: none"> 1. Spring function of the diaphragm spring has degraded due to heat fatigue. 2. Wrong part was installed. 3. Improper driving method. 	
Cure:		<ol style="list-style-type: none"> 1. Improve driving method. 2. Replace cover with correct part. 3. Replace disc and cover with new parts.

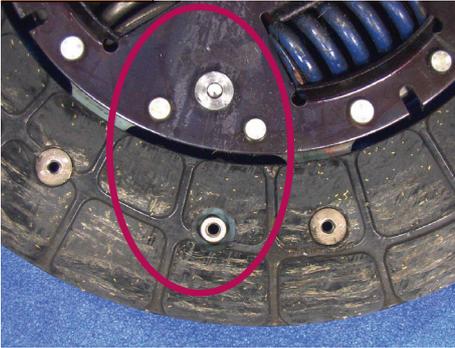
Condition: Oil or similar substance is on the friction surface of the facings.

1. Facing was touched with oily hands when replacing the part.
2. Excess spline grease was thrown onto the facing due to centrifugal force.
3. Improper installation.

1. Replace disc with new part.
2. Do not contaminate facing with oil.

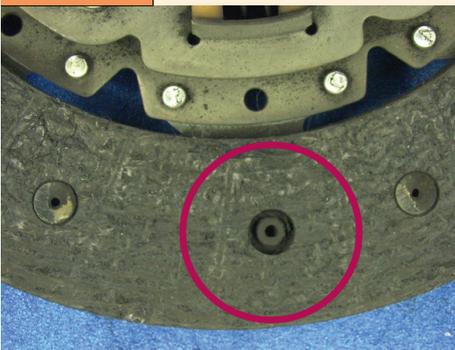
Condition: The friction surface of the facings is showing heat degradation.

1. Facing has reached the end of its wear life.
2. Facing has been scorched due to excessive partial clutch engagement, excessive 2nd gear starts, or excessive downshifting, etc.
3. Improper driving method.

1. Replace disc and cover with new parts.
2. Improve driving method.

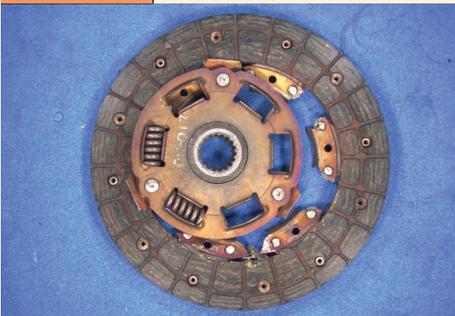
Condition: 2. Broken disc component.

Disc Related Causes	Cover Related Causes	Other Causes
Cause:	1. Misalignment caused disc to break and engine power is not being transmitted. 2. Installation error.		
Cure:	Replace disc and cover with new parts.

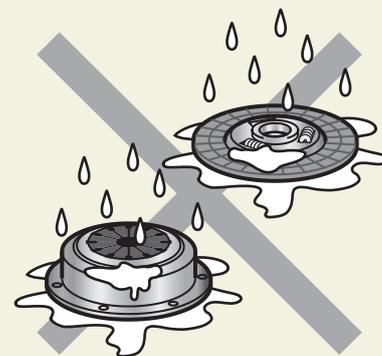
3. Product handling

Do not use a clutch that was contaminated with water or oil.

Oil on the friction surface or rust caused by water could lead to problems (e.g. clutch drag or slipping).

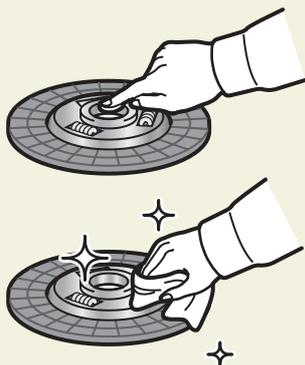
4. Disc Installation

Remove excess grease when installing disc.

Excess grease on the friction surface can cause slipping or shuddering.

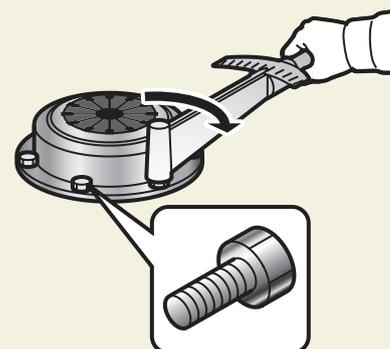
6. Cover Installation

When tightening the cover, use bolts and torque specified from the vehicle manufacturer, using a torque wrench.

Bolts can break if the vehicle manufacturer's specified bolts are not used or not tightened to torque specifications.
